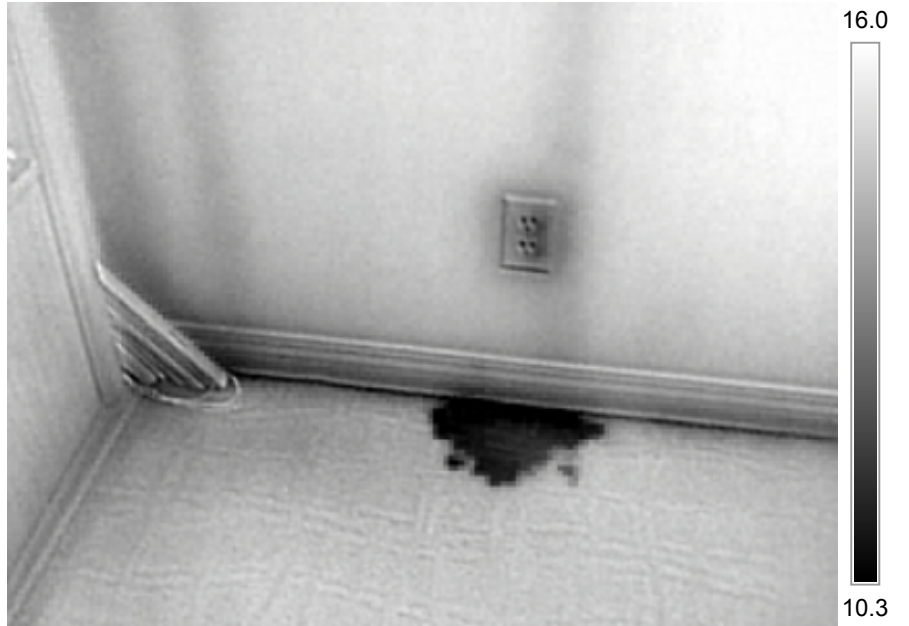
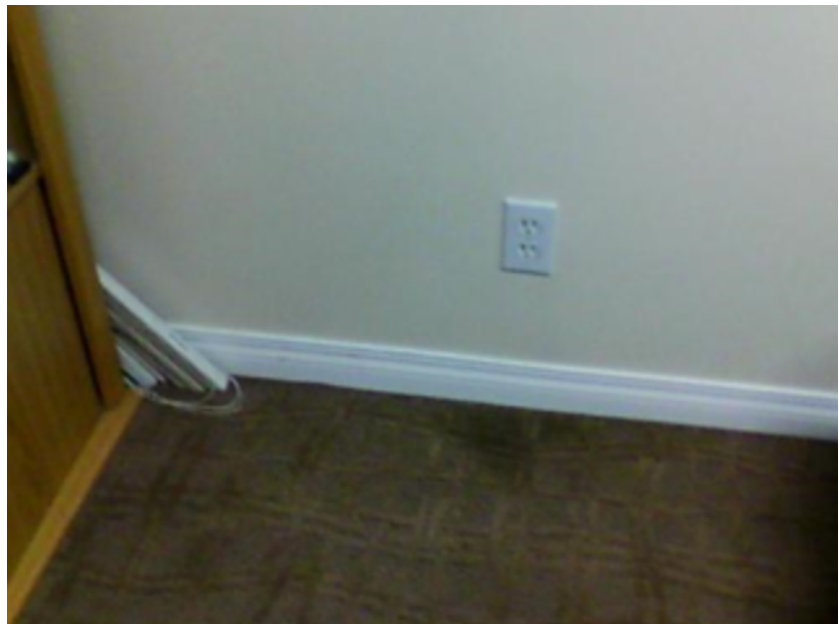
FLIR0119.jpg

Water at a basement wall. Very obvious in the Infrared image, this would probably be missed during a typical visual only inspection.
