A typical electrical panel image captured during an inspection.

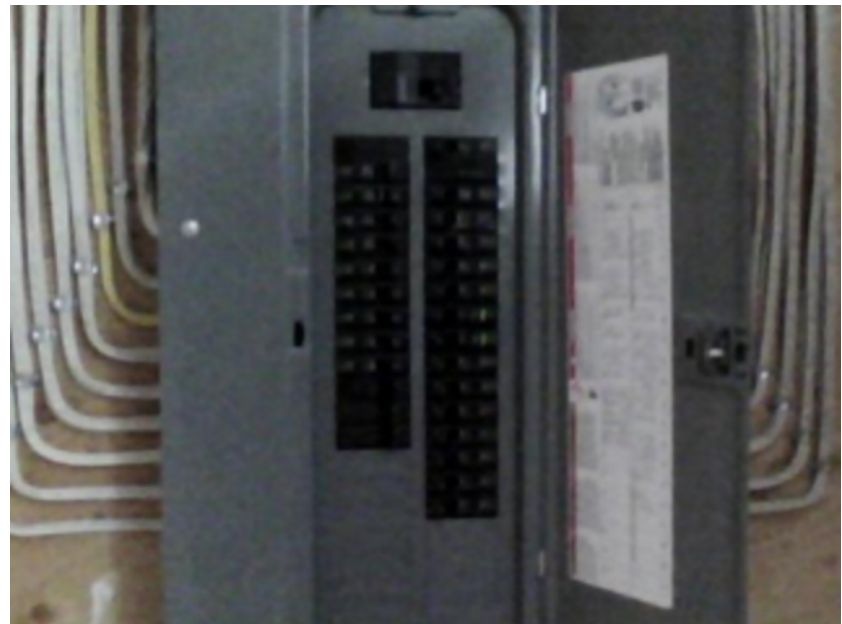
FLIR0082.jpg

Sp1	9.7
Sp2	14.4
Sp3	6.1

Sp2 is the breaker which supplies the furnace, which had been running for some time.

Sp1 is the wire supplying the furnace.

Sp3 is another wire supplying a different circuit in the home.

None of these temperatures are cause for concern. Wires warm up when power flows through them. That this image picks up the small amount of heating in the one wire is an indication of the sensitivity of the camera.
