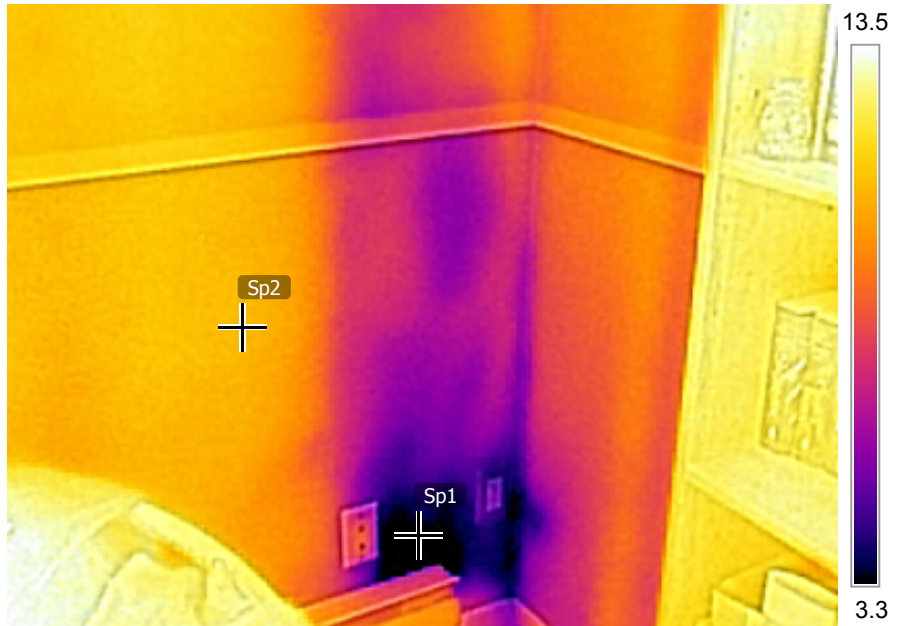
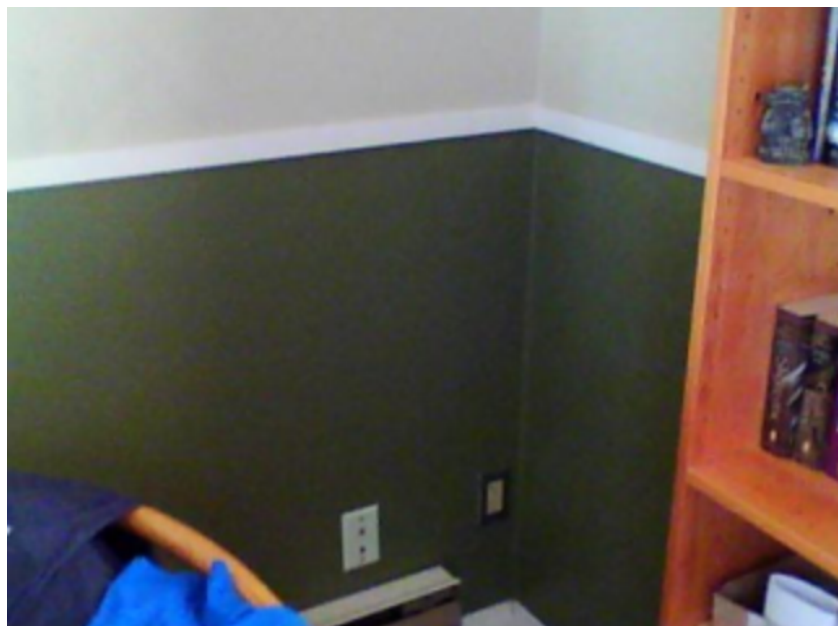
FLIR0041.jpg

Sp1	2.9
Sp2	11.0

Emissivity	0.95
Refl. temp.	20 °C

Further investigation of this area confirmed missing insulation. This made for a drafty bedroom.
